UPPER GROVETON DAM  
N.H. 00148

PHASE I INSPECTION REPORT  
NATIONAL DAM INSPECTION PROGRAM

DEPARTMENT OF THE ARMY  
NEW ENGLAND DIVISION, CORPS OF ENGINEERS  
WALTHAM, MASS. 02154

FEBRUARY 1979

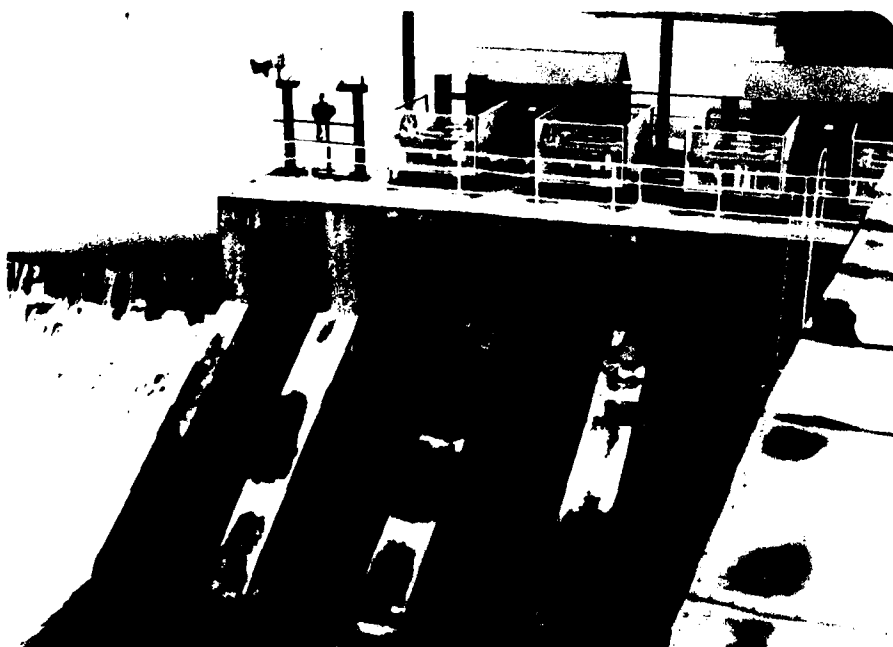
The gate works are in good overall condition. Spalling concrete has been patched and the entire service platform has received a new concrete cap. All of the equipment, hand rails, steps, ladders, etc., are in sound structural condition and have recently been painted.

#4. VIEW OF GATE WORKS
